Prepared for the
38th Joint Propulsion Conference and Exhibit
cosponsored by AIAA, ASME, SAE, and ASEE
Indianapolis, Indiana, July 7–10, 2002

High Voltage TAL Erosion Characterization

David T. Jacobson
National Aeronautics and Space Administration
Glenn Research Center
Cleveland, Ohio 44135

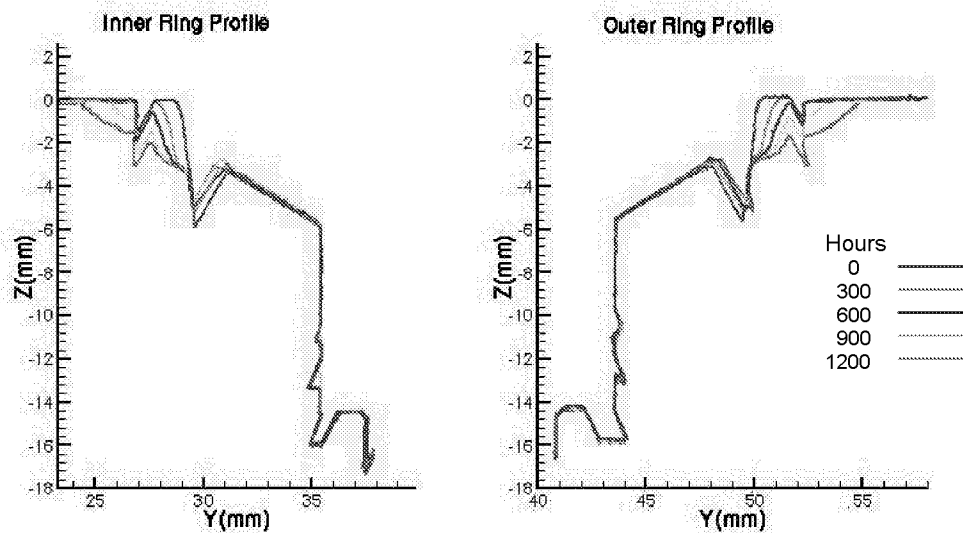
Images of the inner and outer geometry collected at the 0° and 180° positions, respectively, are presented in figures 5a and 5b. These figures reveal differences in the erosion around the circumference and also between the inner and outer geometry at the same angular location. Both the inner and outer ring profiles exhibit progressive erosion of the thruster components with time as expected. There are differences in the inner profiles taken at 0 and 180°. While the two inner profiles presented have a similar appearance for the first 300 hour increment, differences begin to appear over the later increments. The inner ring profile at the 0 degree location indicates that a larger amount of inner guard ring erosion had occurred compared to that at 180°. The 900 hour increment profile taken at 0 ° indicates that the sufficient guard ring erosion occurred to expose the inner magnet pole to ion impingement causing inner magnet pole erosion. At the 180° location, the inner guard ring erosion was low enough to protect the magnet pole for the entire duration of the experiment. While the magnitude of the differences in erosion are smaller, the same erosion phenomenon exists in the case of the outer guard ring. A larger amount of material was removed at the 0 degree location compared to that at 180 °.

Figures 5a and 5b also show a change in the 2nd stage anode electrode geometry with time. The downstream tip of the electrode increased in length by approximately 0.5 mm over 1200 hours. This phenomenon was also evident on the surface of the electrode although to a lesser magnitude. The change was consistent around the circumference and present on both the inner and outer portions of the anode. A visual inspection of the hardware revealed that the anode surface was coated with a loosely affixed material, which appeared to be graphite. While the D-80 had a graphite anode, the surface appearance changed over time. The downstream tip appeared to have small cracks or separation of the surface, which caused the change in geometry seen in the profiles. It is possible that this condition was a result of long term, high temperature operation. While less likely, the loosely affixed material on the anode surface could have been caused by deposition. The material could have originated from the thruster's graphite guard rings or the facility. Because the guard rings and the anode were both made from graphite, determining the origin of the coating on the anode was not possible. No tests were conducted to definitely understand the phenomenon.

Figure 5a: Axial coordinate versus radial coordinate for magnet pole/anode/guard ring profile measured at 0, 300, 600, 900, 1200 hours. (0° azimuthal location)

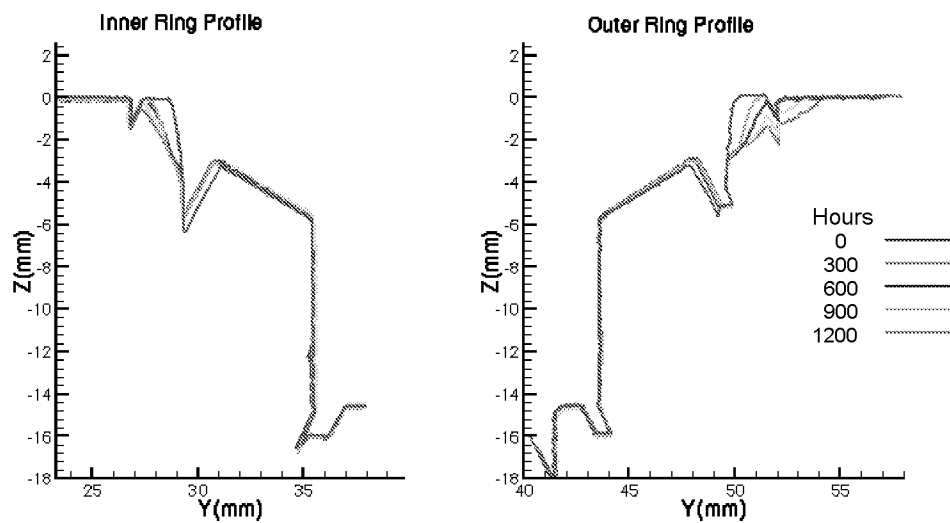
Figure 5b: Axial coordinate versus radial coordinate for magnet pole/anode/guard ring profile measured at 0, 300, 600, 900, 1200 hours. (180° azimuthal location)

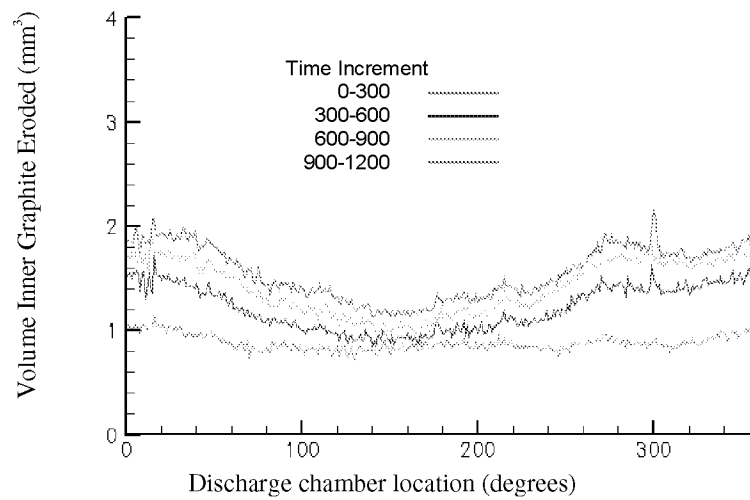
The volume of graphite eroded from the inner and outer guard rings at each degree is presented in Figures 7 and 8, respectively. Similar plots of the metallic volume removed from the inner and outer magnet poles are presented in Figures 9 and 10. The eroded volume of the outer ring is fairly consistent around the circumference over the first 300 hours. One exception is an unexplained sharp decrease in eroded volume observed between 270° and 310°. During subsequent operation intervals, the erosion became increasingly less consistent around the circumference. The eroded volume gradually decreased from 40° to a minimum at 200°, then increased to 270° where it remained fairly constant to 40°. Similar trends are exhibited in the case of the inner component erosion. This asymmetric guard ring erosion caused erosion of the inner magnet pole. Figure 9 shows the eroded volume of the inner pole, which occurred almost exclusively between 0° to 80° and 310° to 360°. Figure 10 indicates that the outer magnet pole erosion was more consistent around the circumference than the inner pole. The sharp change

It is evident that the erosion rate was elevated in the vicinity of the cathode. For both the inner and outer rings, a larger volume of material was eroded between 40° and 270°. A previous Hall thruster erosion test identified discharge chamber misalignment with respect to the magnetic field as the cause for asymmetric erosion.¹⁰ Misalignment of the channel caused elevated erosion on the inner portion of the channel, and lower erosion on the outer portion, which is not observed in this case. A previous TAL erosion study correlated the location of peak thruster erosion with local magnetic field minimums at locations between the electromagnets.¹⁴ In that investigation, the eroded volume was periodic with maximum erosion in regions of low radial magnetic field and minimum erosion in regions of high magnetic field strength. The D-80 erosion was not periodic, nor was the magnetic circuit design suspected as a cause for the asymmetric erosion.

In this case, the localized elevated erosion was likely caused by heavy particle impingement to which the other portions of the channel were not subjected. The particles are thought to be either ions generated in the cathode, or charge exchange ions created by collisions with neutrals escaping from the discharge or cathode. Simple kinetic theory calculations were made to understand the competing effects of the different particles. The path length for charge exchange was estimated using the background pressure and charge cross section for 700 eV ions.¹⁵ The percentage of charge exchange ions was then calculated for the distance between the cathode and the region of elevated erosion. The calculation revealed that only a fraction of a percent of the discharge ions exchange charge. The calculation was also performed using an estimated neutral pressure at the exit of the cathode. At the elevated pressure, a more significant percentage of ions exchange charge. Because the ionization fraction of hollow cathodes is assumed to be small, the dominant effect could potentially be charge exchange ions due to cathode operation. A calculation using the charge exchange ion flux to the region of elevated erosion would need to be made to determine if these particles are responsible for the localized erosion phenomenon.

Figure 7: Volume of inner guard ring graphite removed at azimuthal locations between 0-360 degrees.

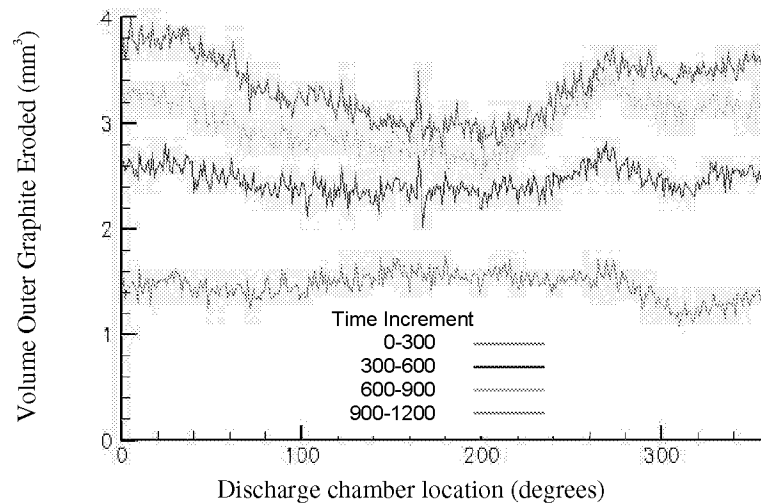
in eroded volume between 270° and 310° observed in the outer guard ring erosion was also present in the outer pole erosion.

Figure 8: Volume of outer guard ring graphite removed at azimuthal locations between 0-360 degrees.

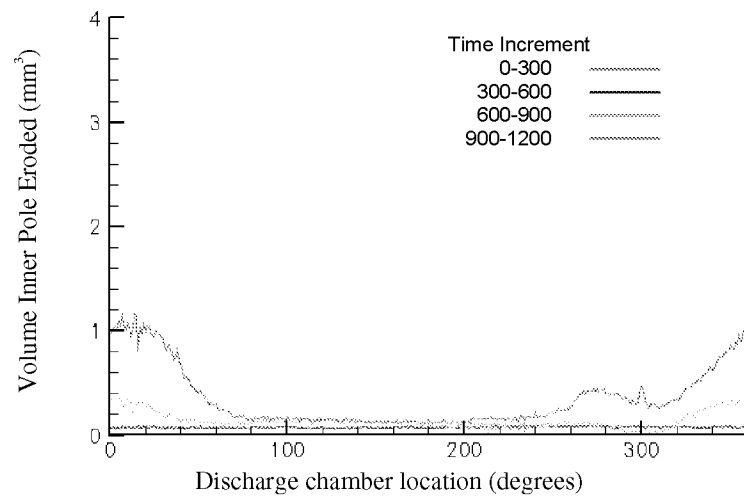
Figure 9: Volume of inner magnet pole removed at azimuthal locations between 0-360 degrees.

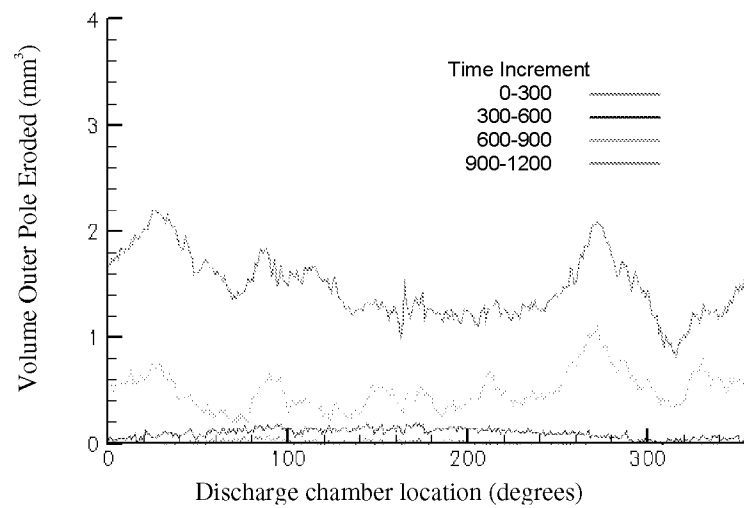
Figure 10: Volume of outer magnet pole removed at azimuthal locations between 0-360 degrees.
